Method for detecting abnormal conductivity of dolphin xp005 probe and milling cutter

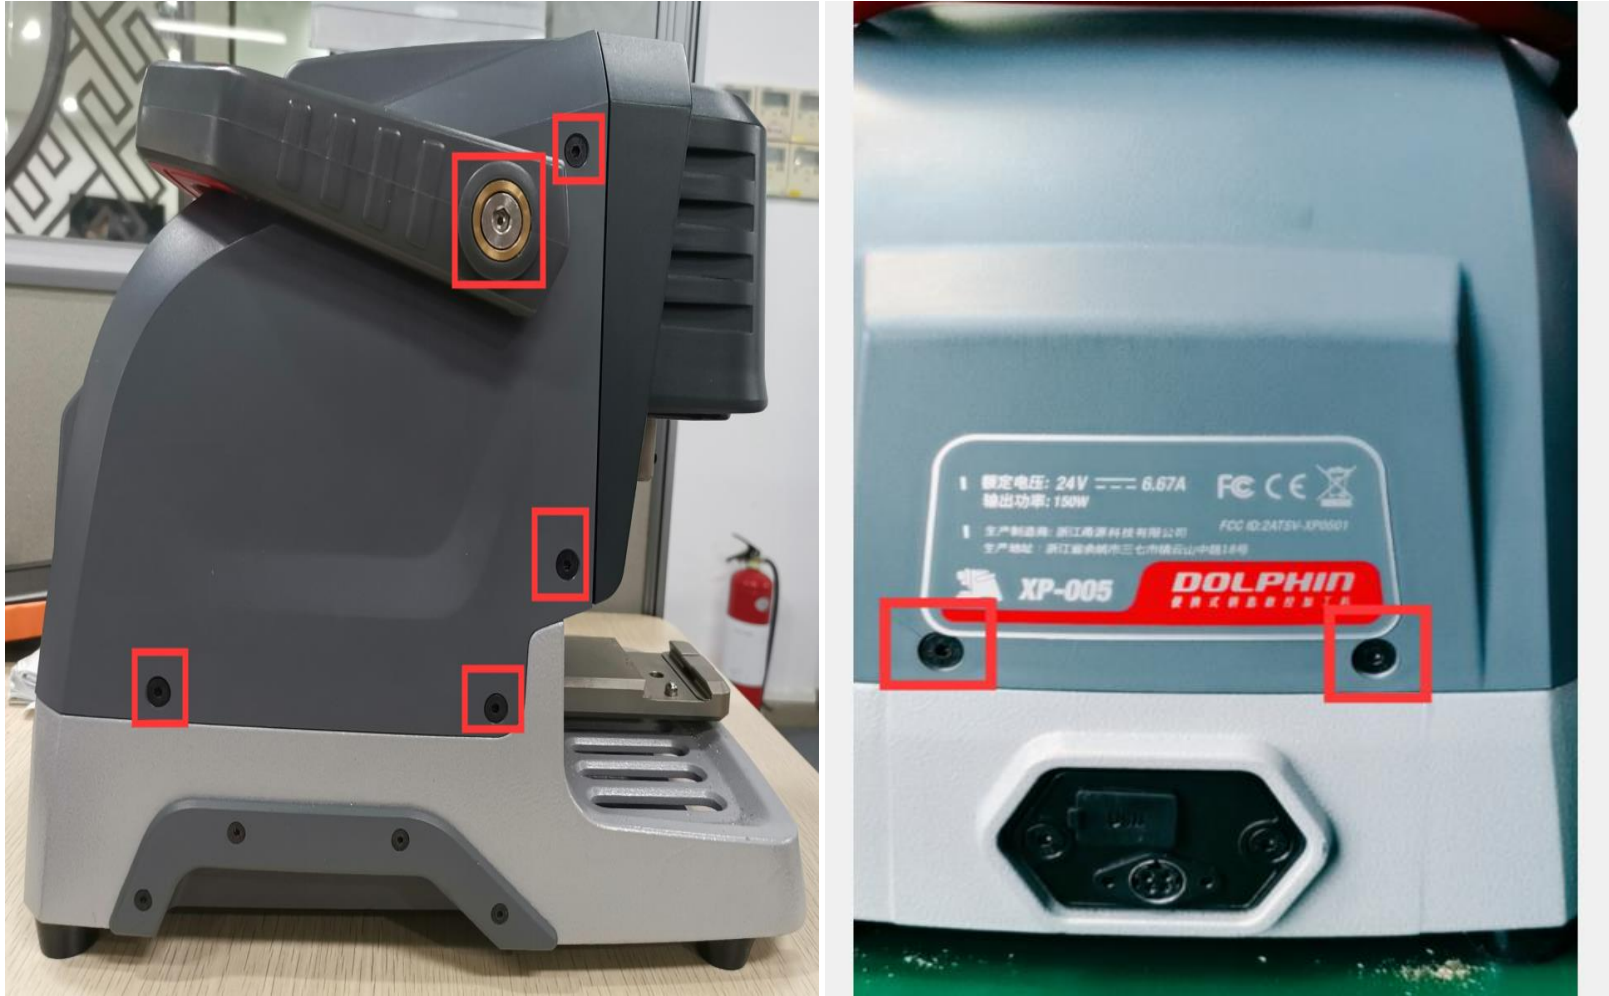
Step1: Disassemble the back cover, and be careful of the wiring harness of the cover when disassembling

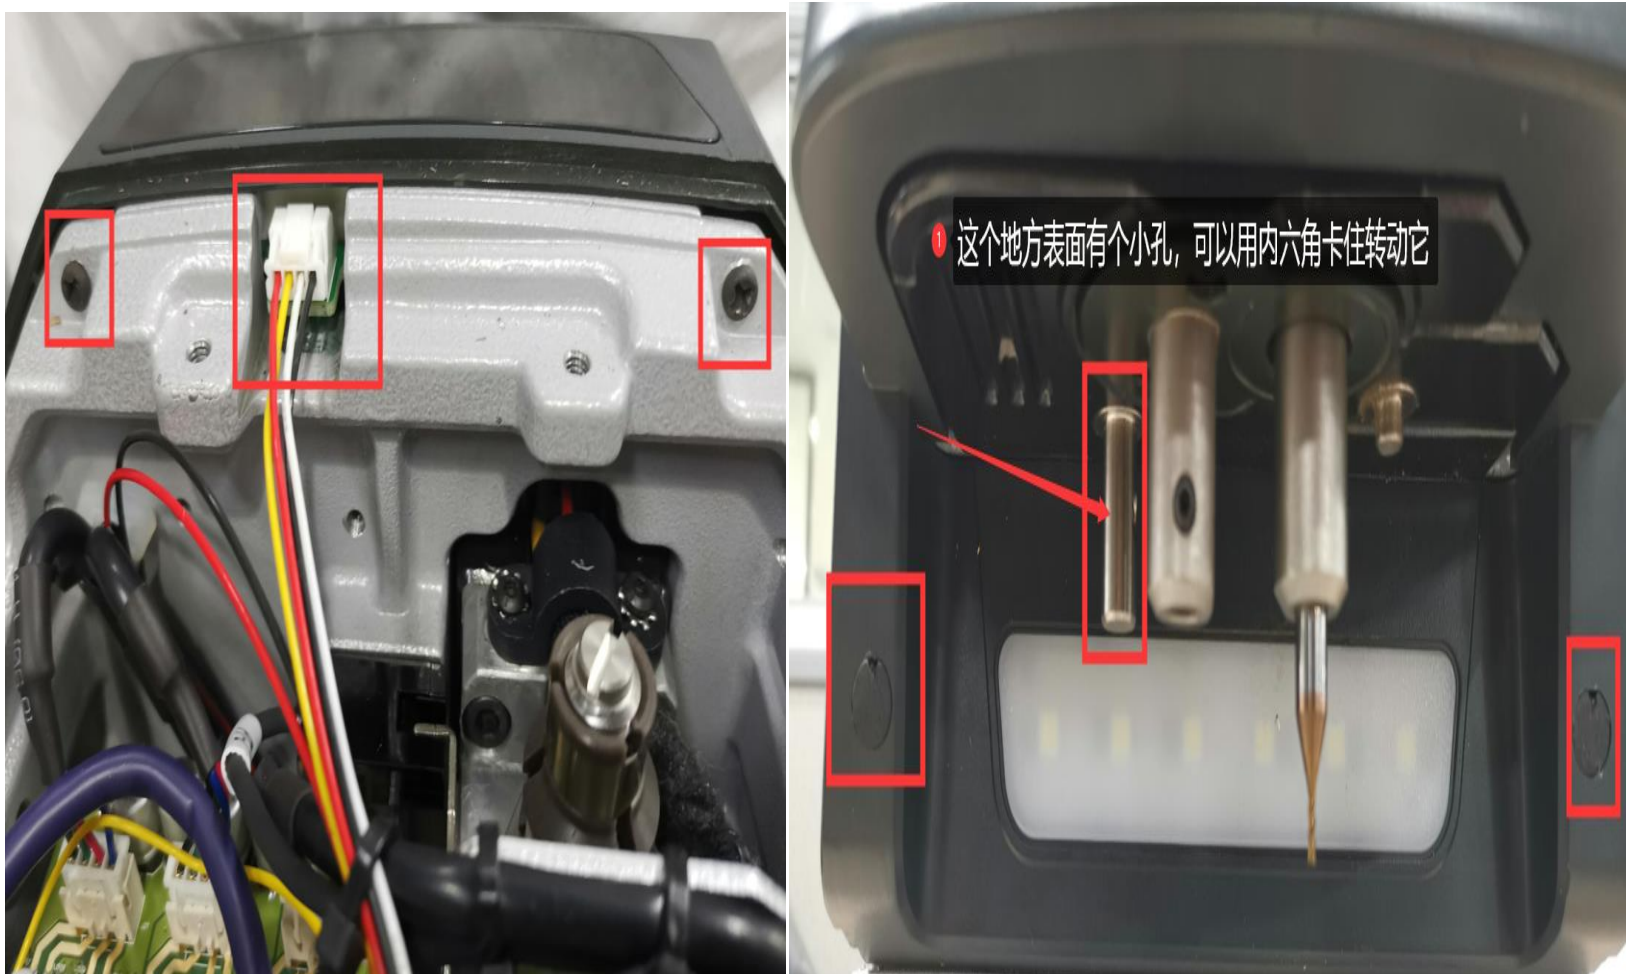
(Figure1)

Step2: Remove the back cover, you can see these things, take off the wire harness, and remove the Phillips screws (see Figure 1). Take out the rubber pellets from the front of the device. There are screws inside. This strip needs to be removed (Figure 2)

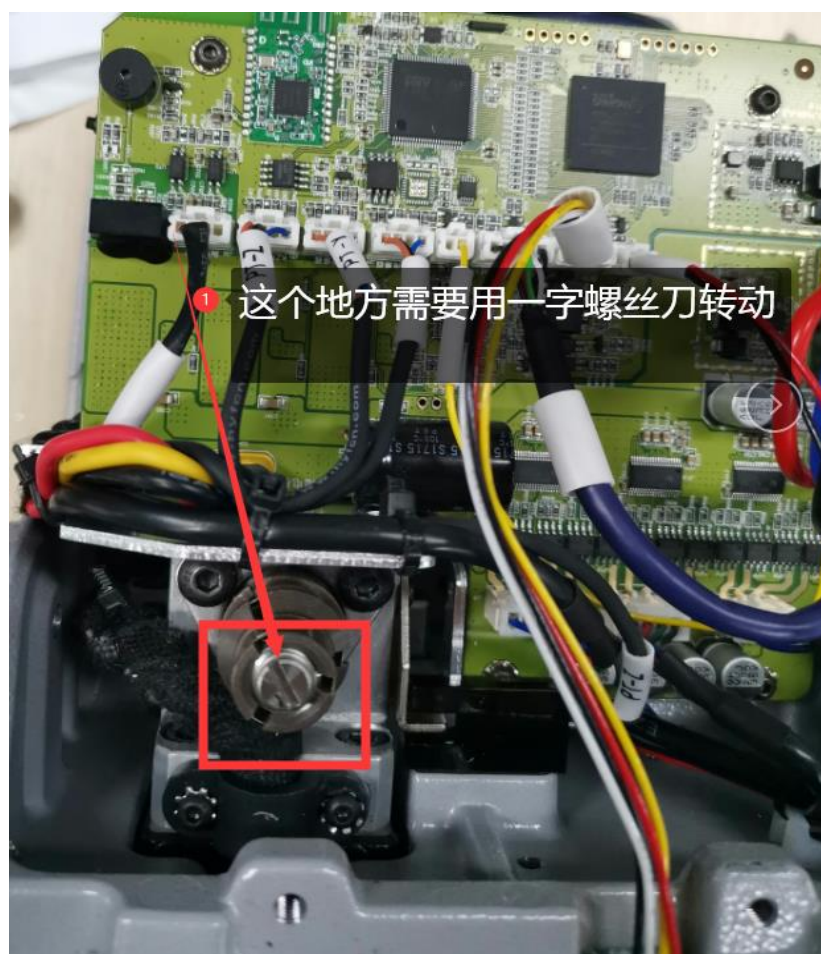
(Figure3)

Step3: Use a flat-blade screwdriver to turn the lead screw, align the Z-axis and the outer cover on a horizontal surface (as shown in Figure 3 and Figure 4), remove the Z-axis housing after alignment (as shown in Figure 5), and place the probe next to it. Remove the screws (as shown in Figure 6). Remember to be careful when removing it. There is a conductive wire inside (as shown in Figure 7).

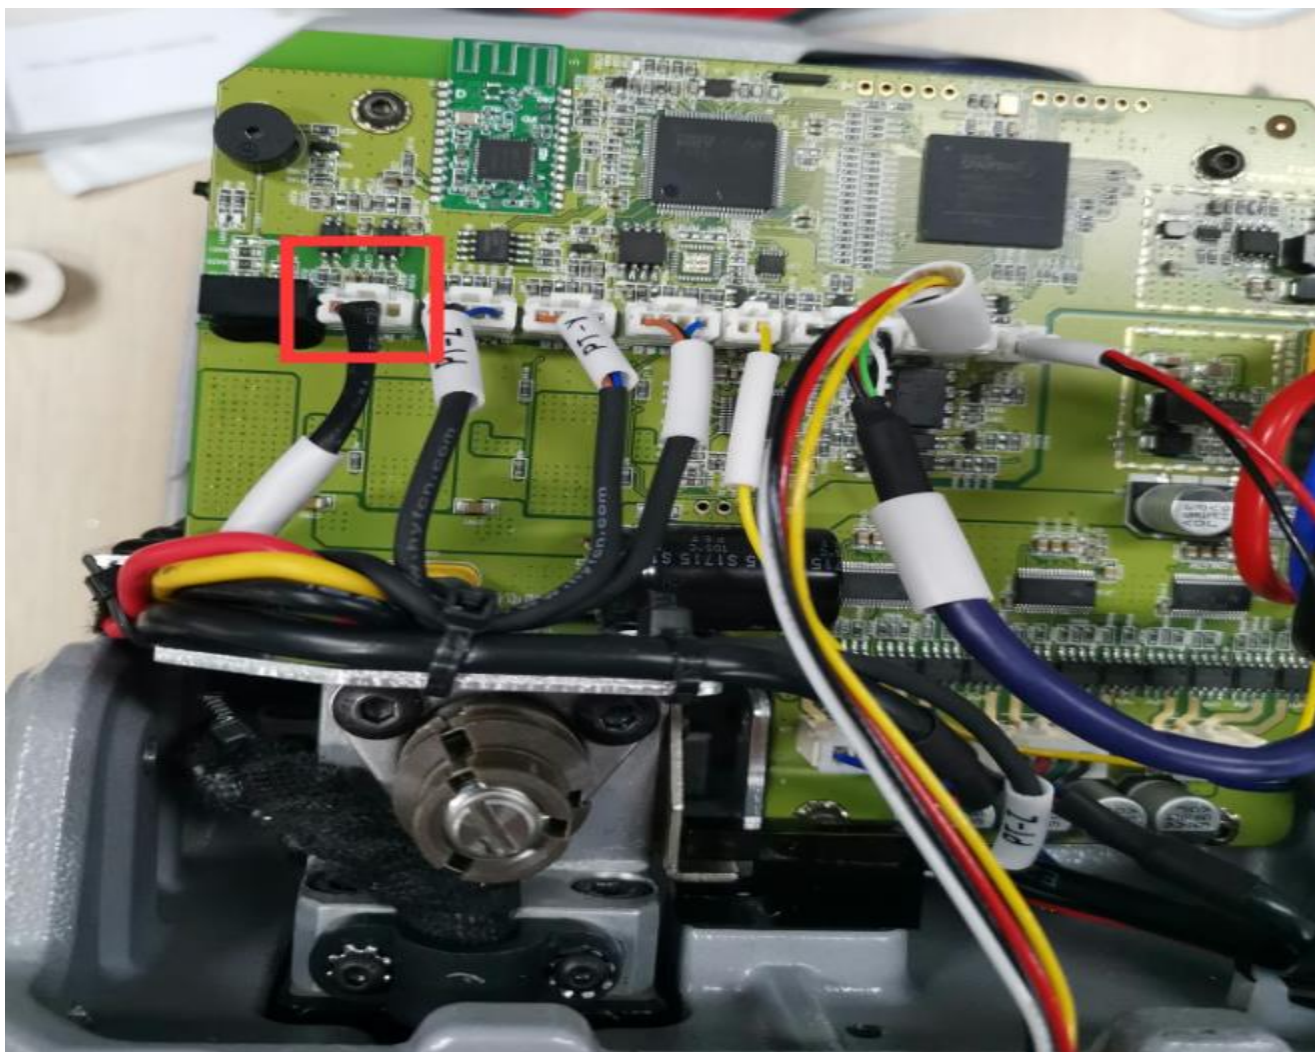
(Figure8)

Step4: If the above steps are all done, the next step is to check whether the conductive wires of the milling cutter and the probe are conductive or short (as shown in Figure 5 and Figure 7), which needs to be combined with the main board to detect. (Figure 8) (or plug in the cable on the main board, and then check whether the conductivity is normal)

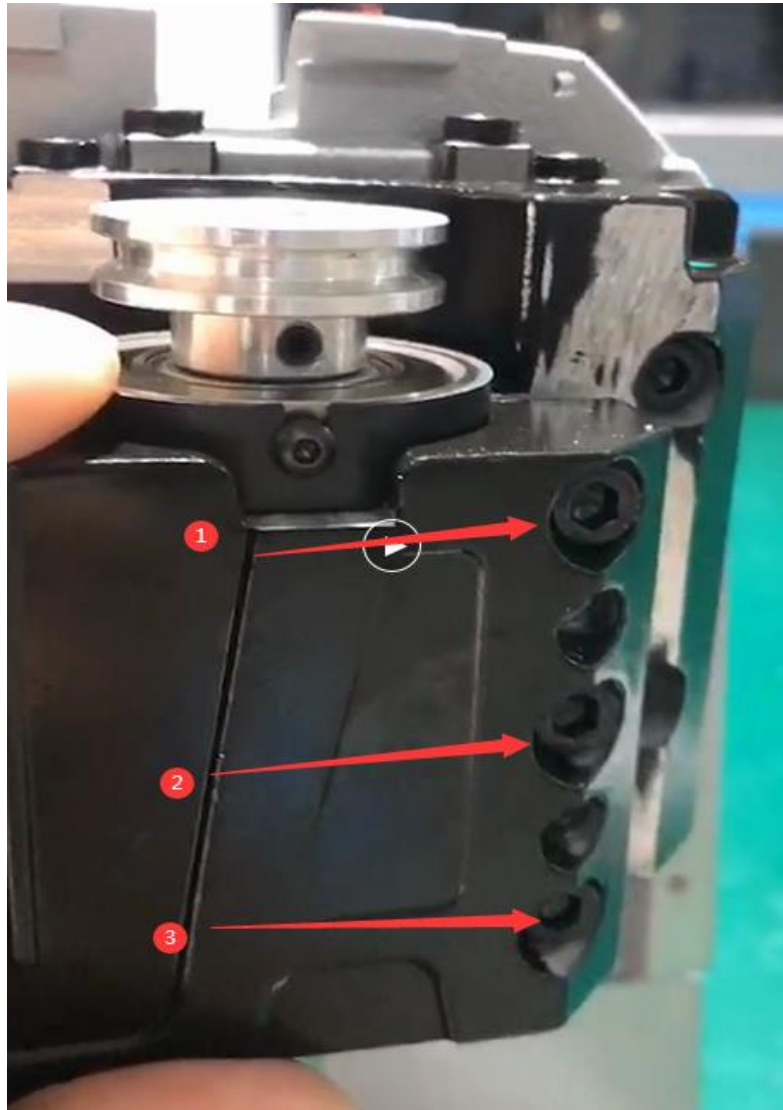
(Figure9)

Step5(conductivity of cutter): Loosen the 3 screws of the Z axis (as shown in Figure 9), and then tighten the two screws (as shown in Figure 10). Push these two screws to the inside until there is a gap. This is to take out the shaft (as shown in Figure 11), press your finger on the position of the milling cutter hole, and push it up with a little force. Come up, and then observe whether the white paper inside is broken (as shown in Figure 12), if it is broken, it needs to be replaced. If it is not broken, observe whether there is iron filings in the bearing hole
